폐플라스틱 열분해 유화 공정의 화재·폭발 위험성 및 안전관리 방안

Fire and Explosion Hazards and Safety Management Measures of Waste Plastic-to-Pyrolysis Oil Conversion Process

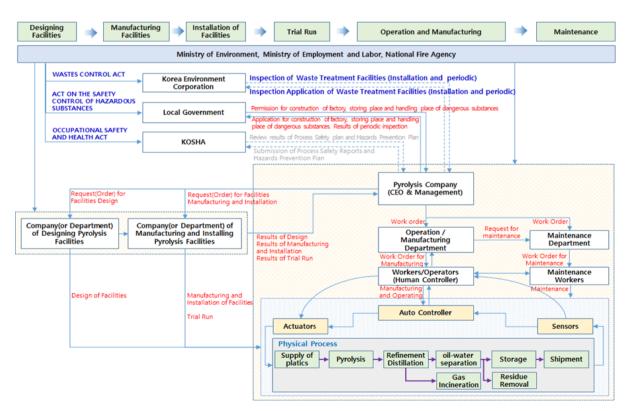
Fig. 1. Safety control structure of the waste plastic pyrolysis process and the related organization

재해조사보고서가 작성된 사고 분석 대상 사업장 7개소 모두 20인 미만의 소규모 사업장이어서 비슷한 조직구조를 가지고 있는 것으로 파악되었기 때문에 7개 사업장의 사고 분석을 위한 모델을 Fig. 1과 같이 하나로 통합하여 작성하 였다. 일부 업체는 자체적으로 설비를 설계하였고, 일부 업체는 중국에서 수입하거나 설비 제작업체에서 구매하여 설치하는 경우도 있었기 때문에 설비의 설계, 제작, 설치는 관련 업체 또는 부서로 표시하였다.

지, 시운전, 운영 및 정비보수로 설정하였고, 조직적으로는 폐플라스틱 열분해업체(부서 포함)와 열분해 공정 및 설비, 열분해설비 설계·제작·설치업체, 환경부, 고용노동부, 소 방청과 이들의 산하기관인 한국환경공단, 안전보건공단, 지자체를 구성요소에 포함시켰다.

Table 4의 분석결과를 보면 4M 분석에서 제시된 사항 외에 정부 및 산하기관, 열분해설비 설계·제작·설치업체의 문제점과 열분해 업체의 문제점도 추가로 도출되었다. 정부 및 산하기관의 문제점은 주로 법적 또는 행정적인 사항들이고, 열분해설비 설비의 설계와 제작, 설치업체 관련 문제점은 설계 시 자체 기준으로 설계 및 제작, 안전장치 미반영, 관련 도면 및 자료 미제공, 방폭 기준 미적용, 설계오류 등이었다.
